**Clover Creek Watershed**  
**Agricultural TMDL Implementation Plan**

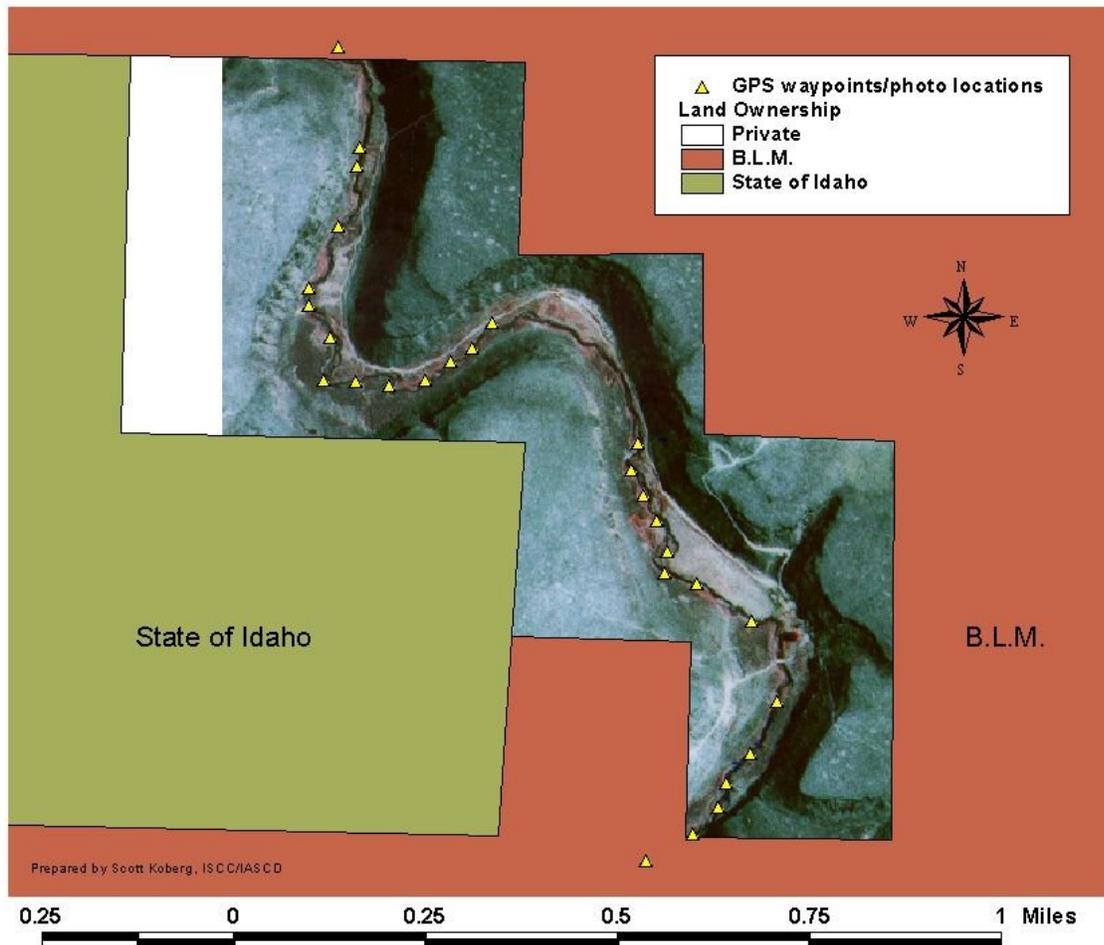
Figure 7. Parcel #1

*The reach within the parcel from the upstream property boundary to the road crossing (no bridge) was considered functional-at-risk due to the following reasons:*

- Channel is in transition from a Rosgen F to a C, where some point bars are beginning to be formed, but the entrenchment ratio is mostly less than 2.
- Channel is still over-widened and shallow, where bankfull ratio is typically greater than 12.
- The vegetative species indicate adequate soil moisture but the quantity of stabilizing species is not adequate, much less than a typical 85% needed for good stability in this setting. The herbaceous species present are mostly baltic rush, a colonizer.
- Peach-leaf and coyote/sandbar willows are present and should be adequate for good regeneration, if adequate water supply is available after seedlings are established. The past low water years seems to be limiting willow regeneration.
- Bank sloughing is occurring, but is necessary for the development of a wider floodplain within and below the historical floodplain, now abandoned.

*The lower reach assessed, from the reservoir check dam to the downstream property boundary was considered to be at functional-at-risk, but nearly at proper functioning, due to the following reasons:*

- Channel is still in transition from pre and post 1900 uses.
- The vegetative species indicate adequate soil moisture but the quantity of stabilizing species is not quite adequate, less than a typical 85% needed for good stability in this setting. The herbaceous species present are mostly baltic rush, a colonizer, with some upland species still mixed in.

- Peach-leaf and coyote/sandbar willows are present and should be adequate for good regeneration, if adequate water supply is available after seedlings are established. The past low water years seems to be limiting willow regeneration.

- Only one outside bank seemed to be cutting into the terrace wall, where no vegetation was growing (waypoint 26), but will be limited due the canyon wall and bedrock.

- In comparison, this reach has progressed farther than the upper reach, but still has some channel narrowing to occur and willow species to become more dominant, such as the peach-leaf willow.

Though both reaches have been assessed as functional-at-risk, the current grazing management does not seem to be having a significant impact on riparian conditions. The stream channel and vegetation is still adjusting to pre and post 1900 impacts, and is slowly recovering due to limited water availability. Ground water is available, but floodplain development is slow. Regeneration of the willow species will continue to occur slowly until some higher precipitation years occur, back-to-back, providing enough moisture for the peach-leaf and whiplash willows to become more dominant.

- Winter (Oct. – Apr.) use by livestock should be monitored by the landowner to ensure that any willow utilization during this period is kept to a minimum. While mineral supplements may reduce willow use, landowner may need to consider culling out any livestock who are repeat offenders with regard to willow utilization.
- Although fencing does not appear to be a necessity for livestock management within the stream segment on this parcel, the landowner should continue to maintain upland watering facilities, feed away from the stream if possible, and maintain salt licks in the nearby uplands.
- From late spring through October, where just a few renegade livestock may have substantial impact on such few willows, landowner should maintain a livestock-free riparian area.

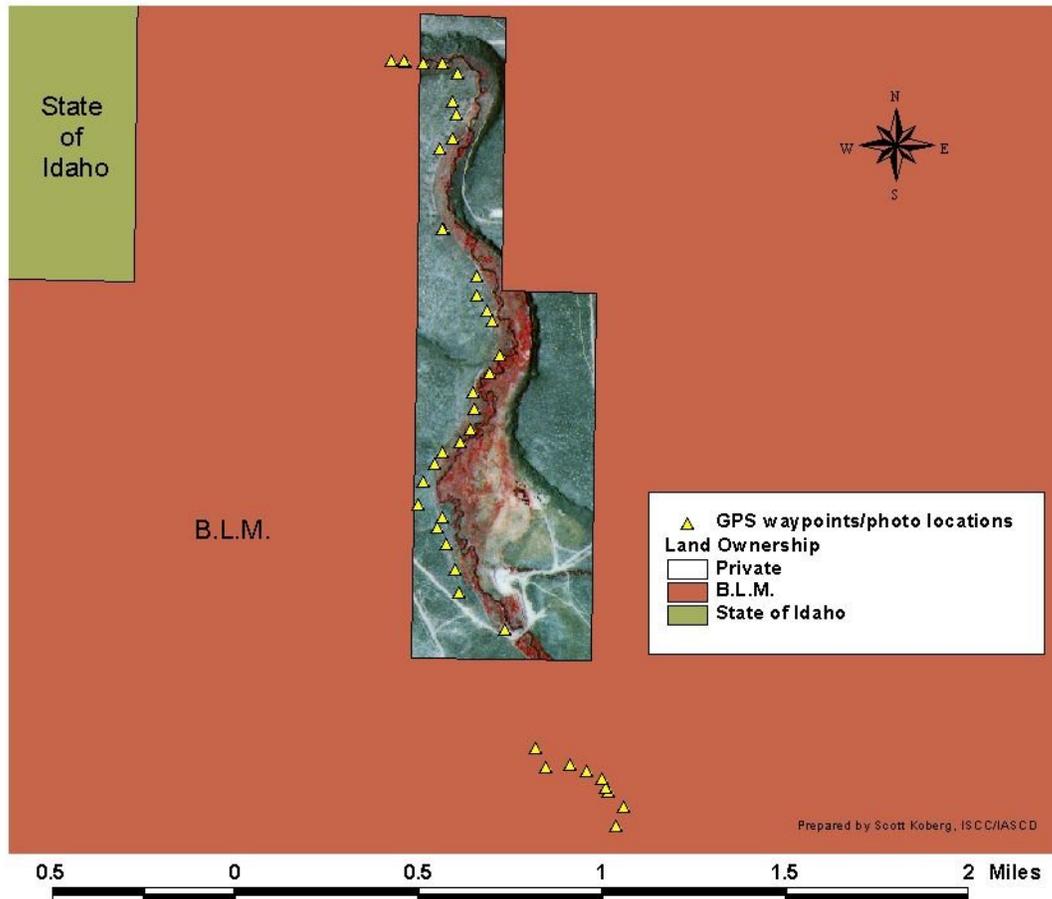
Figure 8. Parcel #2

- Bank stability is poor and compaction problems are evident within the meadow pasture.

- The season long use by livestock (bulls) is having the greatest impact on woody species and bank stability within the lower portion of the meadow pasture.

- Water availability is limited in the lower portion of the meadow pasture as compared to the upper portion, likely due to irrigation water influences.

- Some gully erosion is occurring from irrigated pasture wastewater return to the creek.
- The floodplain in the meadow pasture is still be expanding and livestock access is influencing channel development.

- The entire reach from the bridge to the lower property boundary has over-widened channels, with stream depths less than desired.
- In the upper portion of the meadow pasture, mineral supplements and seasonal grazing have reduced woody species utilization.

- There exists the potential of an oxbow being formed in the near future at waypoint 36, potentially, increasing the stream gradient.

- Where bank stability is a significant problem within the meadow pasture, season long grazing should be adjusted to seasonal grazing with the use of cross-fencing and/or stream-side fencing to allow for livestock rotation within the riparian and adjacent pastureland area.

- Where there is an extensive amount and diversity in vegetative species, there is no need for plantings to enhance bank stability. Grazing adjustments will likely allow for rapid growth where water is readily available to herbaceous and woody species.

- Gradient control does not seem necessary within the area, so it is not recommended that in-stream structures, which would likely cause further bank erosion, be installed.

- While the stream channel is still adjusting to past incisement (head cutting), and where the floodplain is still increasing, bank erosion must still occur to compensate for the current entrenchment. Thus, bank stability may still be limited by hydrologic factors even where grazing adjustments are being made.

- Where livestock have numerous water access points to the creek, bacterial contamination is of greater potential. Off-site water facilities, fencing, and hardened crossings should be considered to reduce the number of access points to the creek.

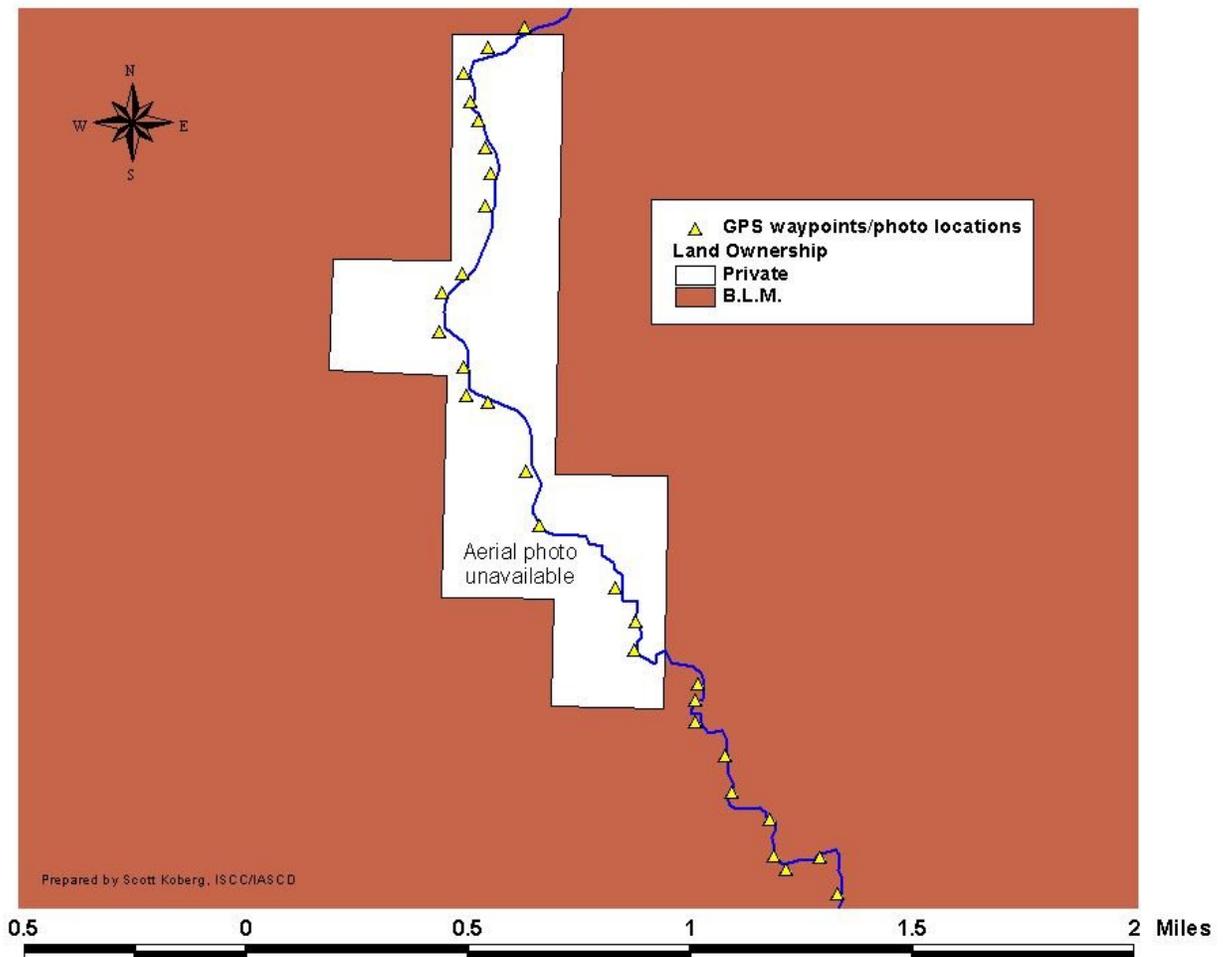
Figure 9. Parcel #3

- Channel is a C3 Rosgen type, but includes some bedrock and gravels.
- Channel is still over-widened and shallow, where bankfull width/depth ratio is typically greater than 12, but the spike rush and coyote willow are narrowing the channel.
- The vegetative species indicate adequate soil moisture but the quantity of stabilizing species is not adequate, much less than the typical 85% needed for good stability in this setting. The herbaceous species present are mostly spike rush, a colonizer.
- Peach-leaf and coyote/sandbar willows are present and, in time, will provide more stability and channel definition.
- Grazing management, where woody species are being slightly over-utilized, should be adjusted to ensure good vigor and regeneration success.
- Where there is a well-developed floodplain, very little bank erosion or sloughing is occurring.

- Channel is still in transition from pre and post 1900 uses, where it is more entrenched, with limited floodplain access below the abandoned historic floodplain.
- The vegetative species indicate adequate soil moisture but the quantity of stabilizing species is not quite adequate, less than the typical 85% needed for good stability in this setting. The herbaceous species present are mostly spike rush, a colonizer. Some water sedge (type unknown) is also present in small, thick patches.
- Coyote/sandbar and peach leaf willows are present, with little utilization occurring.
- In comparison to the upper reach, less floodplain development has occurred, especially below the confluence with Juniper draw.

- Channel is less entrenched than the middle reach, where there exists a wider floodplain.
- The vegetative species indicate adequate soil moisture but the quantity of stabilizing species is not quite adequate, less than the typical 85% needed for good stability in this setting. The herbaceous species present are mostly spike rush, a colonizer. Some water sedge (type unknown) is also present in small, thick patches.
- Coyote/sandbar and peach leaf willows are present, with little utilization occurring.
- Spike rush, coyote willow and other riparian species are less abundant in this reach compared with upper and middle reaches which have more non-riparian species on the stream banks.

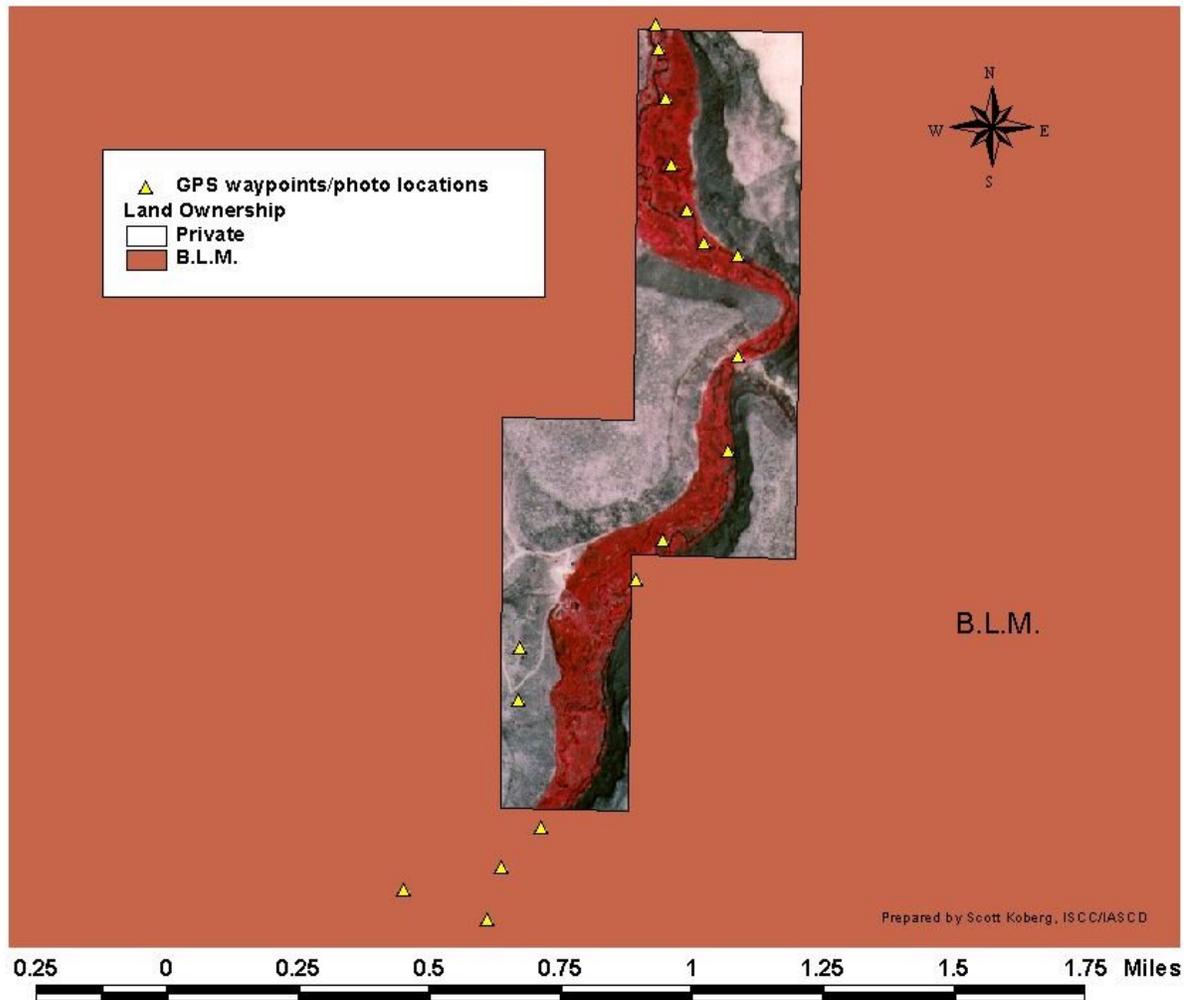
Figure 10. Parcel #4

- Channel stability is provided by the spike rush, roots of live woody vegetation, and the cobble/boulder substrate.
- Historical use has impacted the channel sinuosity in order to increase pasture area, and has caused the channel to shift to the east side of the narrow valley.

- The stream channel had been straightened many years ago, which causes a higher entrenchment than the lower pasture reach, though willows are more dominant here and are providing stability, along with more cobble/boulder substrate.

- The vegetative species indicate adequate soil moisture and the quantity of stabilizing species is higher than the lower pastures, though at some locations (more downstream), rushes and some bank erosion is more evident.

- Channel is a C4 Rosgen type, but includes some cobble.
- Channel is still over-widened downstream of the old fence line but only for a very short section. The majority of the reach has a bankfull width/depth ratio of greater than 12, moderate to low entrenchment, with adequate floodplain to dissipate energy.
- The vegetative species indicate adequate soil moisture, a fair quantity of stabilizer species, but less than what will likely occur given time and similar management. The herbaceous species present are mostly a spike rush, a colonizer.
- Multiple willow species are present and becoming the dominant.
- Little bank erosion or sloughing is occurring, where there is a good stability from vegetation, though still developing and adequate floodplain.
- Some livestock water access points exist, but do not seem to effect stability.

- Though bank erosion is excessive at the one location within the upper pasture, stability may come within a few years, without much more bank erosion, where the stabilizing species are migrating downstream into that section. Some willow planting may quicken stability. Any improper channel alteration would likely cause down cutting, potentially lowering the water table within the upper pasture above this point. A gradient change is likely causing the bank erosion, where stream gradient is less at this point than upstream within the channelized section.
