Blackfoot River Total Maximum Daily Load Implementation Plan for Agriculture

Developed for the Idaho Department of Environmental Quality

February 2005

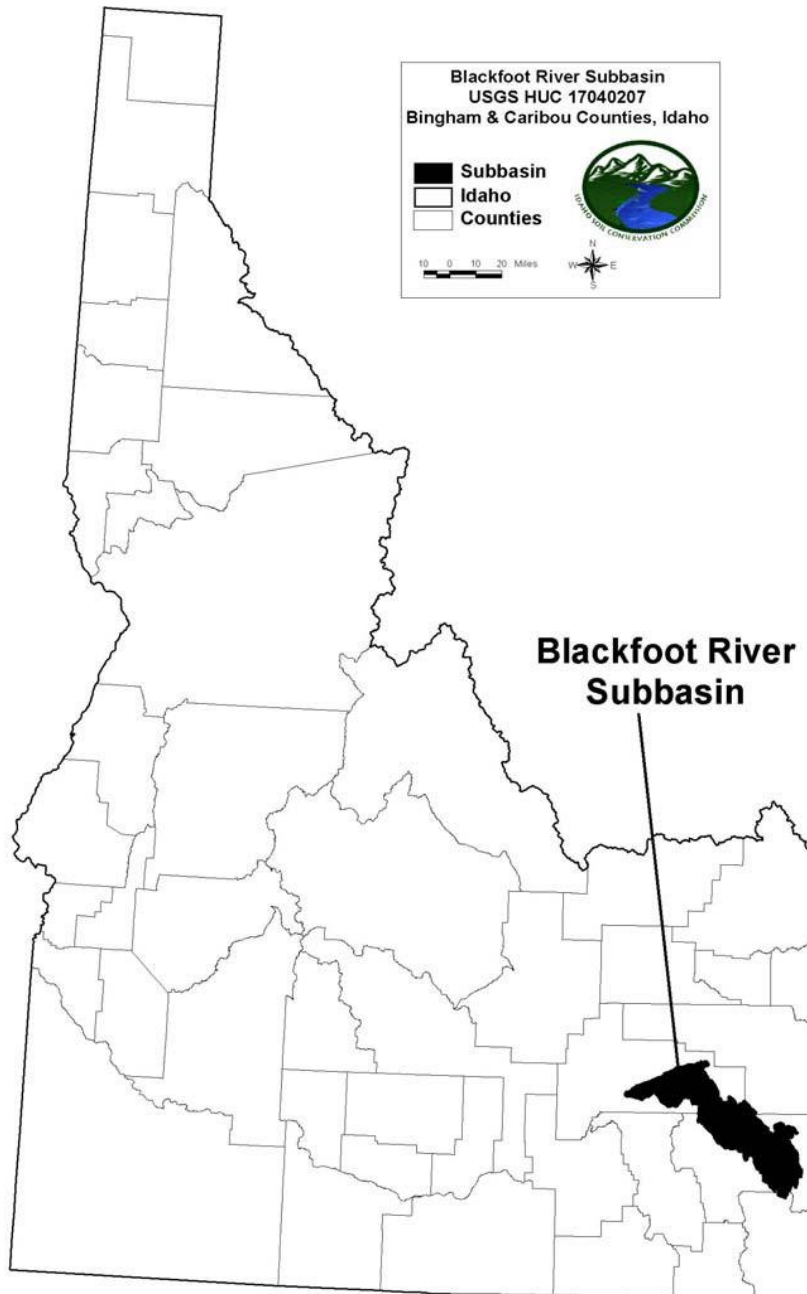
Figure 1. Location of the Blackfoot River Subbasin

The Blackfoot River subbasin is located in southeastern Idaho and covers parts of Bingham, Bonneville, and Caribou counties as shown in Figure 1. The subbasin covers 699,489 acres or 1,093 square miles.
