Conservation the Idaho Way

IDAHO SOIL & WATER CONSERVATION COMMISSION

MARCH 2024

CLEARWATER DISTRICT PARTNERS WITH POTLATCH-DELTIC TO REPAIR GRANDAD FOREST ROAD

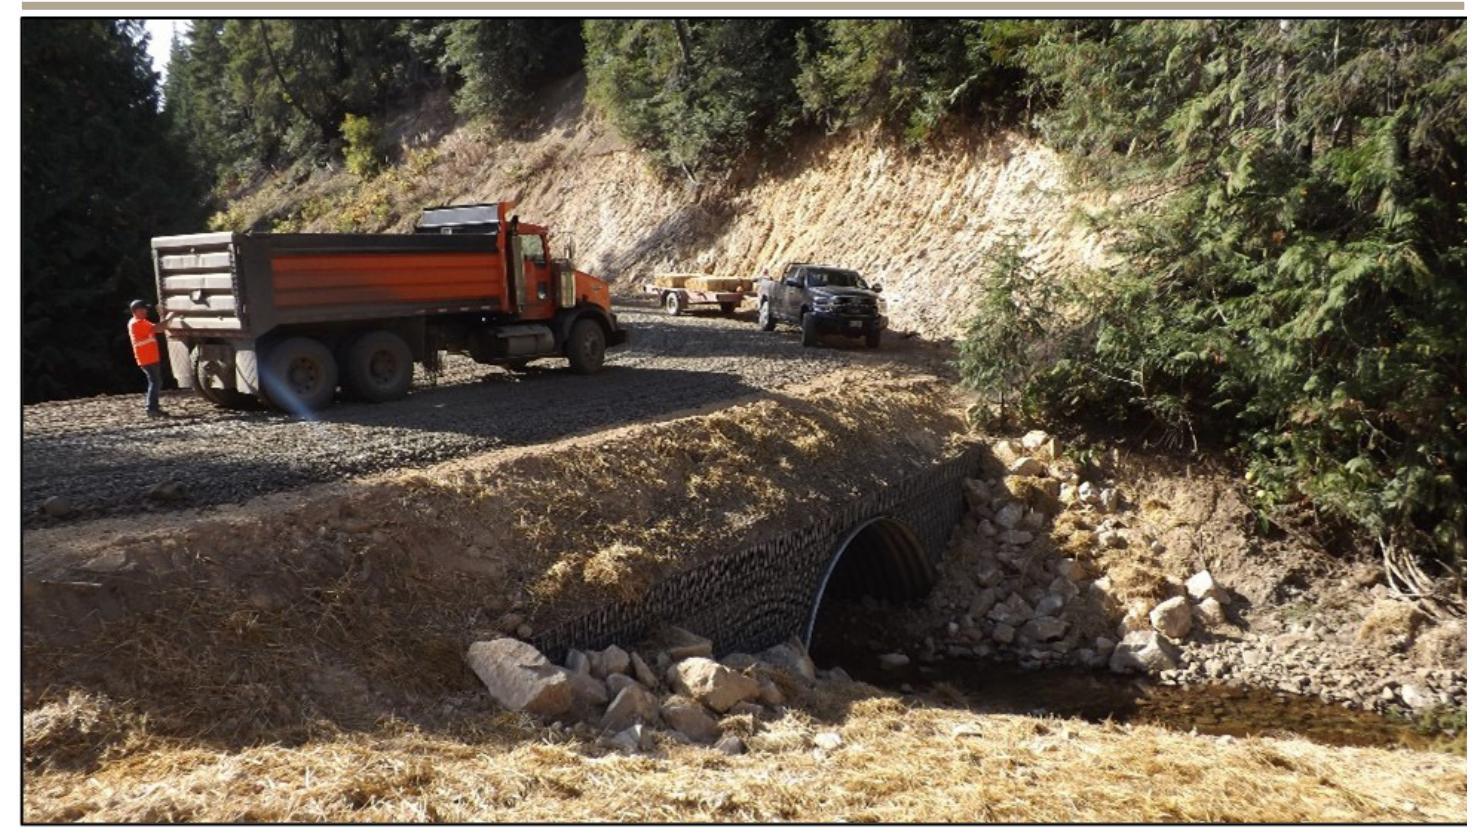
All finished up! Contractors re-built a key portion of Grandad Road, an important public access road for recreation and forest management located in the upper reaches of Dworshak Reservoir. (photo courtesy Clearwater SWCD)

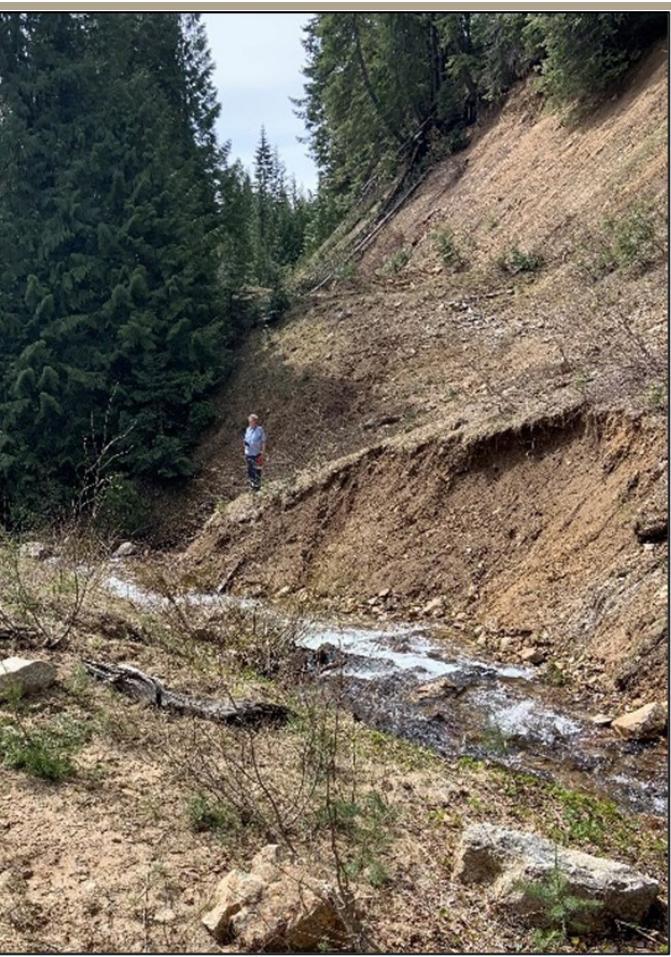
In the spring of 2012, the Grandad Road got washed out by a flood and had to be closed for 10 years. A 60-inch culvert plugged during the washout and subsequently failed. A half mile away, a big landslide took out the entire road.

Above, locator map of the landslide and road project. Right, the washout above Garden Creek, pre-project. (photos courtesy Clearwater SWCD).

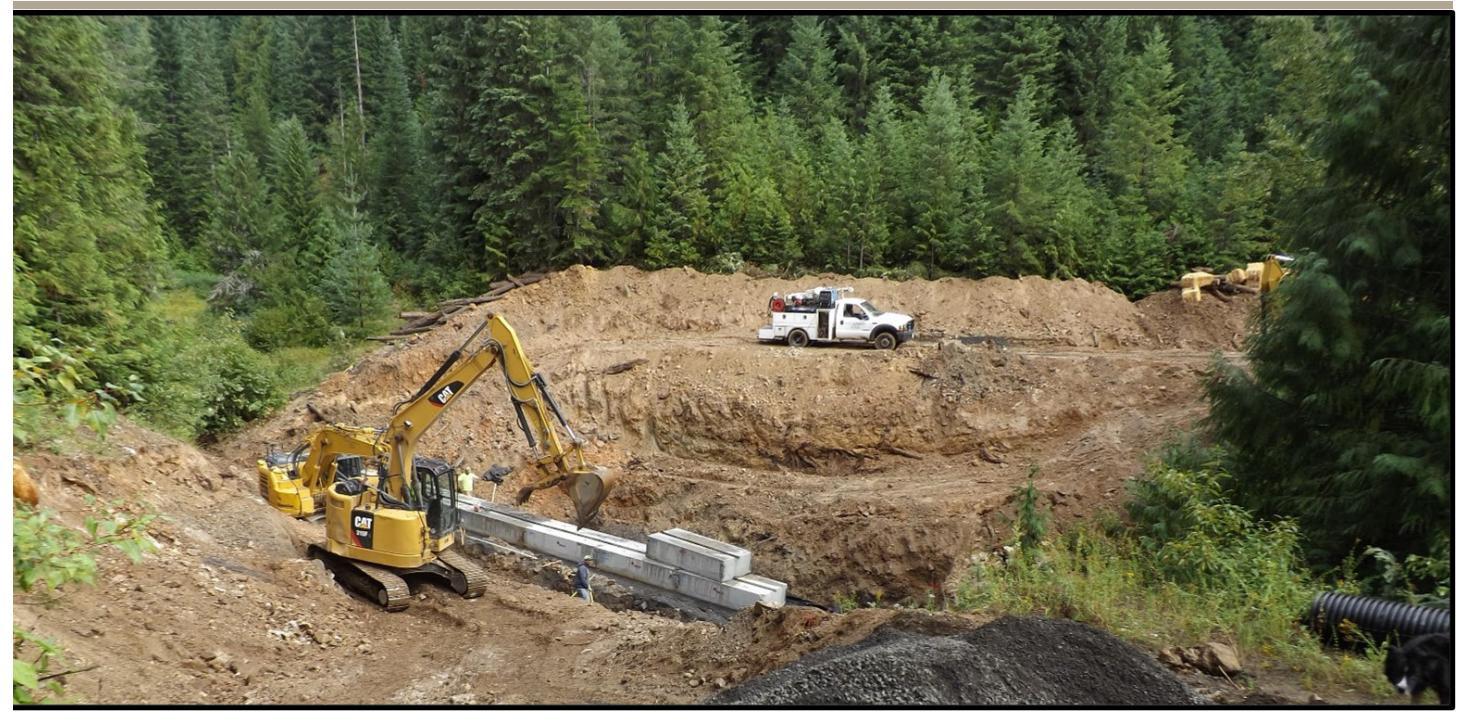
Contractors install concrete footings for an arched culvert to be placed at the Garden Creek crossing. (Clearwater SWCD)

Finally, in September, construction crews had access to the Garden Creek stream crossing. They excavated the site, removing over 500 cubic yards of unsuitable material, and rebuilt a channel to grade with rock weirs, she said. Then they set the concrete footers, placed and bolted together the structural plates to form the bottomless arch culvert on the footers.

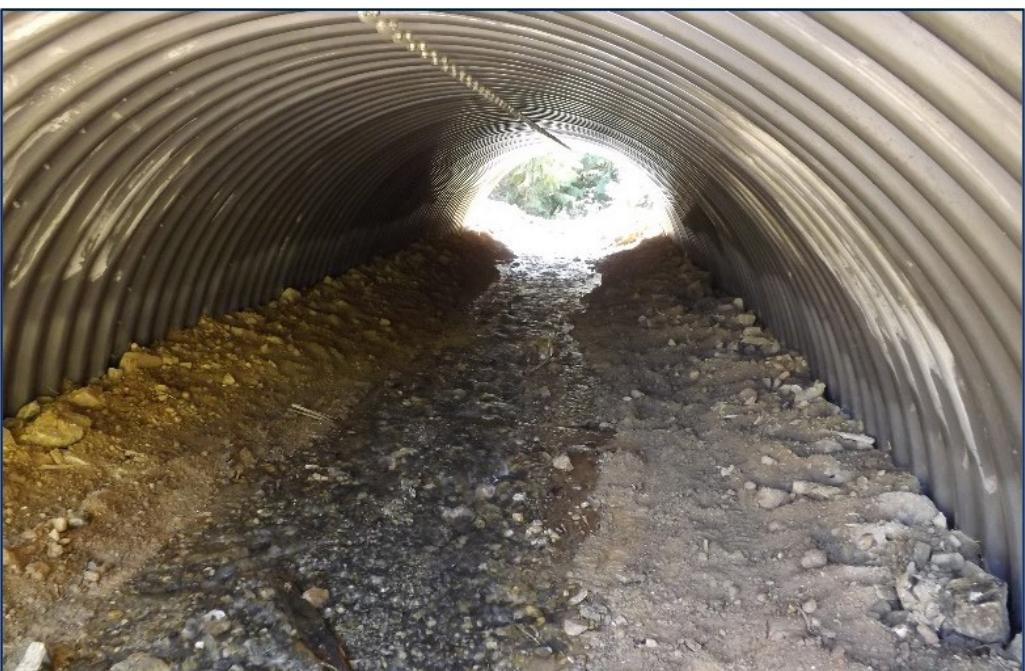
Arched culvert allows for fish passage in the restored creek bed. (Clearwater SWCD)

while building retaining walls at the inlet and outlet, and brought the road up to grade. The new 60-footlong bottomless arched culvert is 15 feet wide with a 7-foot, 9-inch rise. It's set on an 8 percent grade with a geotextile and riprap slash pad at the outlet.

The new culvert is fish-friendly, Connor noted, and should benefit resident fish and aquatic life.

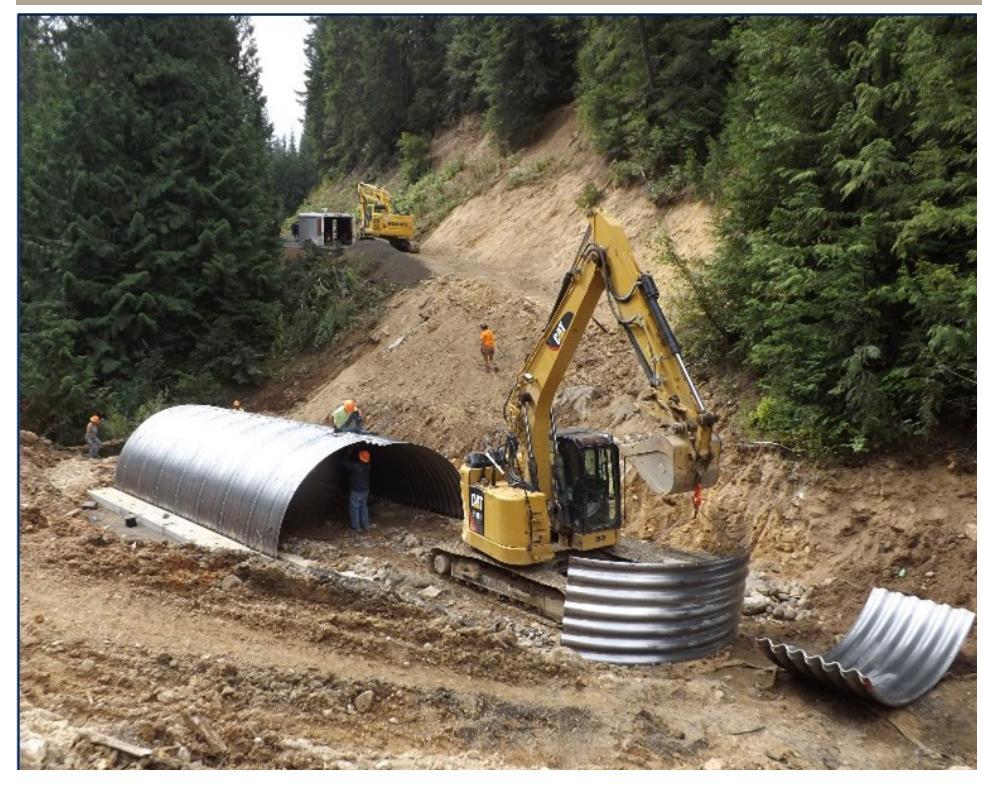
Contractors work on placing the arched culvert on top of the concrete footings at the Garden Creek crossing. (photo courtesy Clearwater SWCD)

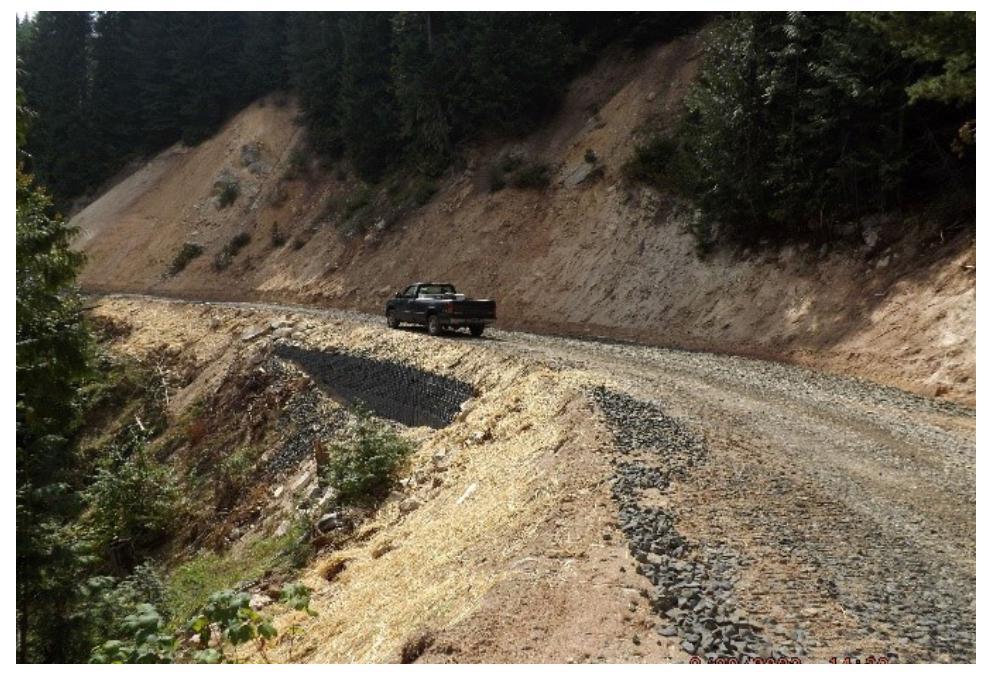
New road reconstruction in the landslide area. (courtesy Clearwater SWCD)

Next, the road was widened to a standard 20-foot width by installing vertical Hilfiker retaining walls on the fill side. Trucks bringing in rock for fill for the walls and aggregate to place over the slide areas had to back up for the last quarter mile into the site because there was no space to build a turnaround, she said.
