# **Big Wood River Watershed Total Maximum Daily Load (TMDL)**

## **Implementation Plan for Agriculture**

**October 2006**

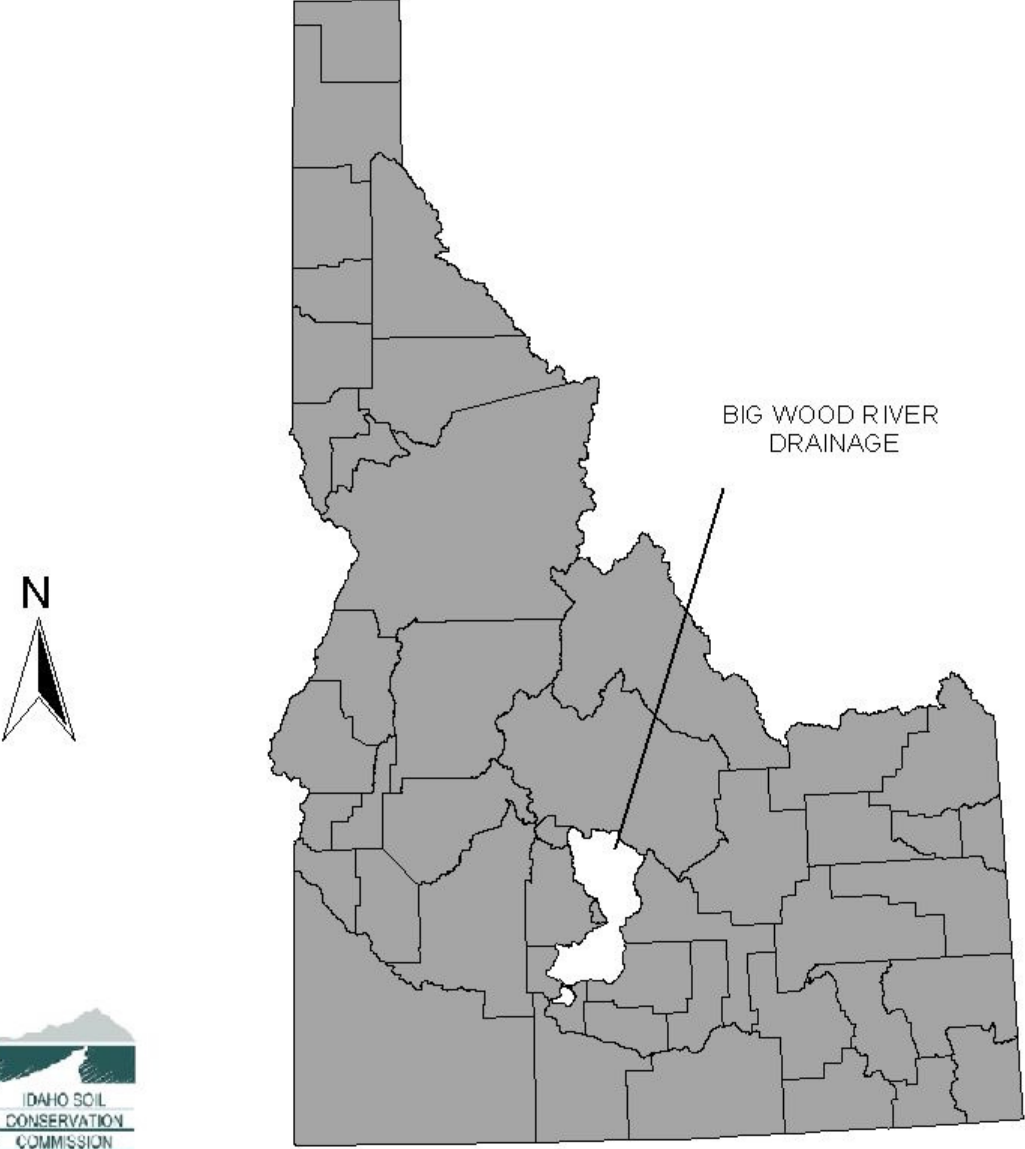
# BIG WOOD RIVER LOCATION MAP

The Big Wood Watershed is located in South-Central Idaho ([See Map 1, Big Wood River Location Map](#)) and totals approximately 958,172 acres. Elevations in the Big Wood Watershed range from 11,112 feet at Silver Peak, in the Boulder Mountain Range of the Sawtooth National Forest, to 2760 feet at the confluence at the Snake River. The watershed borders Custer County in the north, and includes Blaine, Camas, Lincoln, and Gooding Counties.
